HIROSHIMA, JAPAN - BAMBOO BARRIER™ RHIZOME PRUNING PROJECT

PRODUCT: WB 36

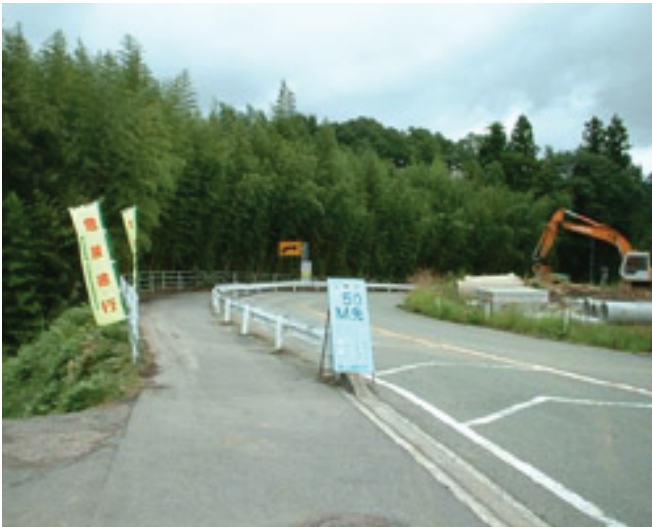
Damaged Multi-Use path

Rhizomes from the adjacent bamboo forest were causing this multi-use path in Hiroshima, Japan to buckle and heave. Tired of the on-going problem and costly repairs the local authorities sought a more permanent solution. After removal of the damaged asphalt a trench was dug and the rhizomes pruned. DeepRoot WB 36 was then installed to block future surface rhizome growth.

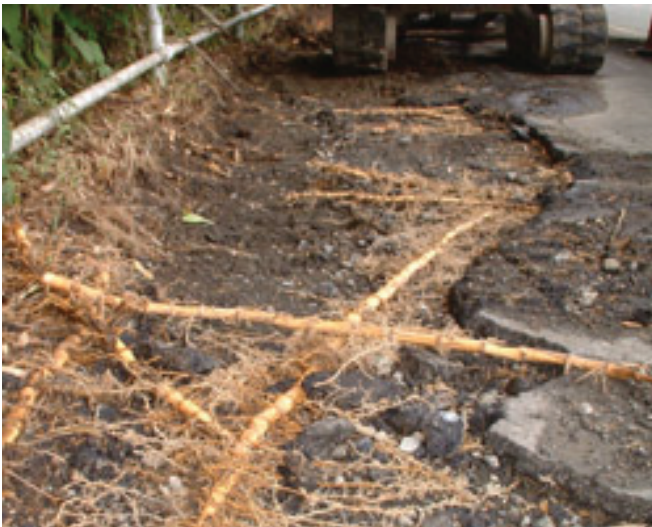
Surface rhizomes

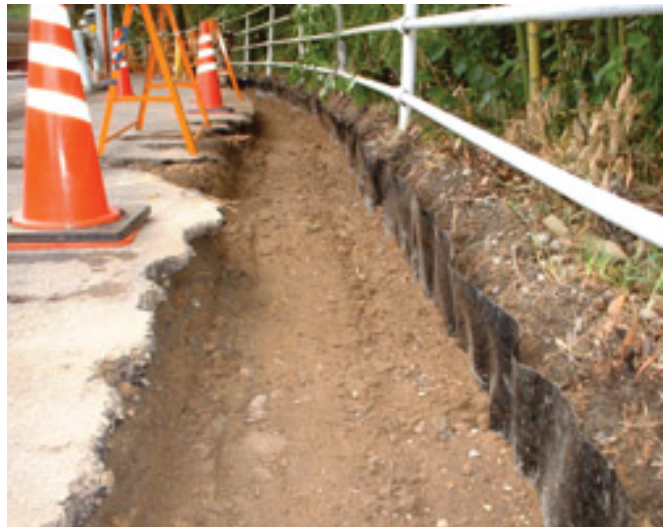
BambooBarrier™ installed
