TWO NEW TREES REPLACE POISONED PREDECESSORS

Toomer's Corner at Auburn University Once Again a Campus Gathering Place

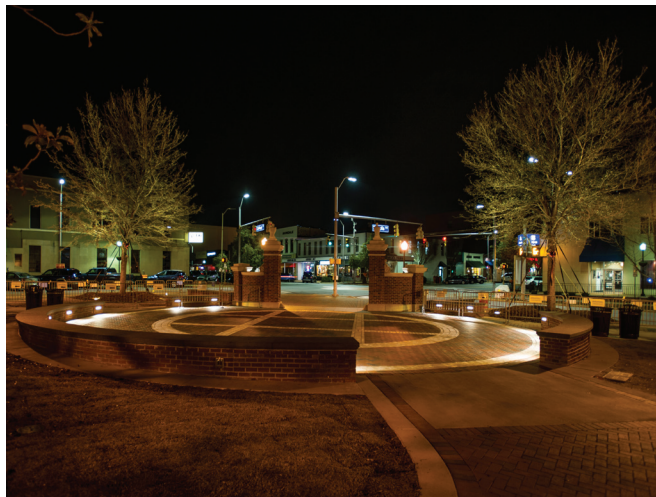
The central (round) area between the two trees is classified as a bioretention zone, with 3' of clean granite stone - neutral pH for the trees - topped with permeable pavers. The idea is to keep water on-site rather than sending it to a storm pipe. There is an underdrain at the bottom of the stone with an upturned elbow and another underdrain at 6' deep. There will be a large reservoir of water available for the trees at all times. Where the Silva Cells are directly adjacent to the circle, the tree roots will only have access to rainwater within the stone. The intent is for the roots to get in there and use the water and air provided.

grow to at least the same age as their predecessors, and therefore needed to provide them with plenty of soil. He decided to make the openings of the tree wells as large as possible, and then used a one-layer Silva Cell system

to extend the planting area underneath the sidewalk and slightly into the rounded entranceway to the campus.
